Reducing Pasture Road Erosion

Rubber conveyor belting offers a solution.

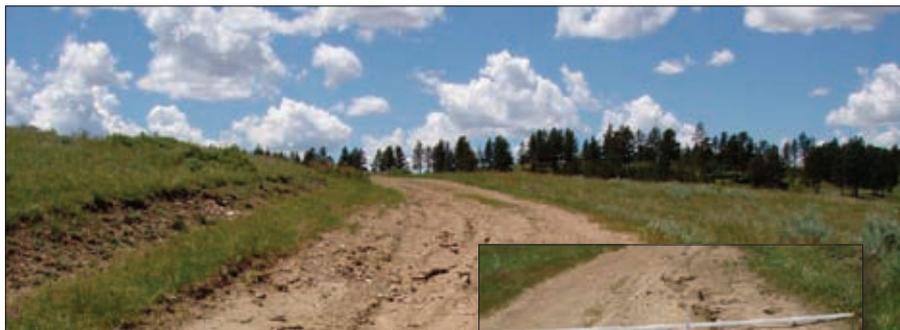
► **Above & right:** These photos show eroded gullies on pasture roads.

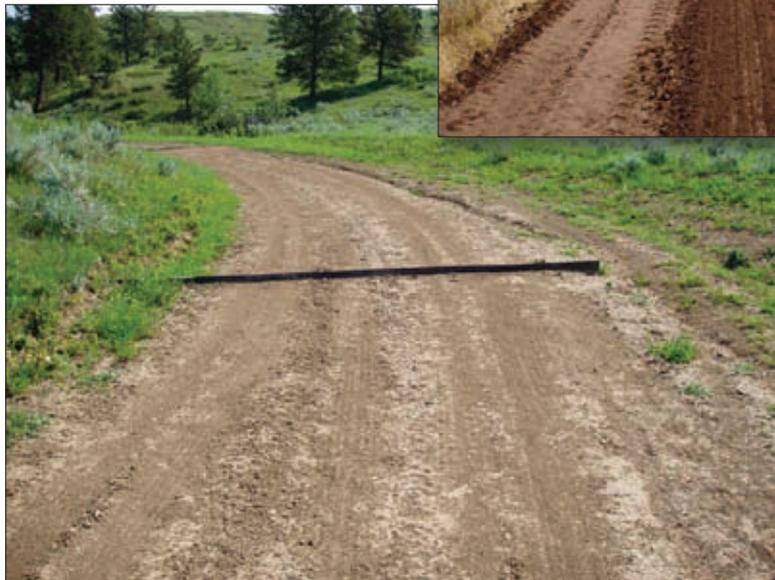
► **Above & left:** These photos show improved roads with rubber water diverters installed to reduce erosion.

Kilian explains that rubber conveyor belting is used in strips 15 inches (in.) wide and 16 feet (ft.) long. Each strip is mounted to a treated 2 × 4 board, a trench is made across the road at an 11° angle, and the belting is buried so 1½ to 2 in. remains out of the ground and helps divert water across the road. These diverters are placed about every 80-100 ft., depending on slope, along the road where erosion occurs.
